THE SECRETARY
OF THE INTERIOR'S
STANDARDS FOR
REHABILITATION &

ILLUSTRATED
GUIDELINES ON
SUSTAINABILITY
FOR
REHABILITATING
HISTORIC
BUILDINGS

U.S. Department of the Interior
National Park Service
Technical Preservation Services

2011

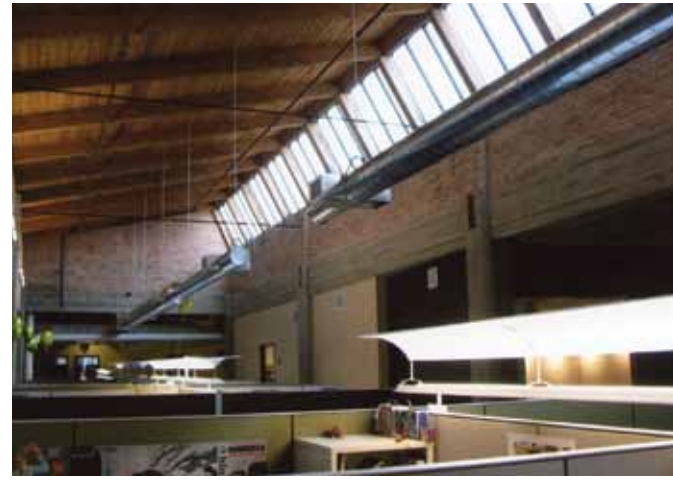
[2-3] Clerestory windows provide natural light in a historic industrial building: Before and after rehabilitation.

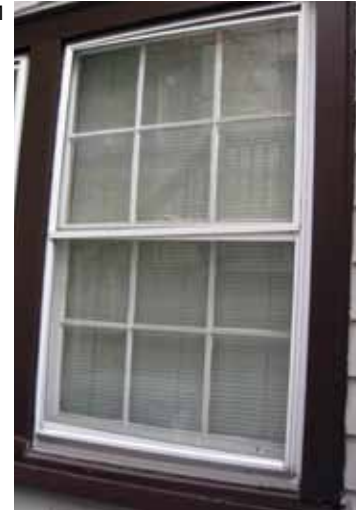
31

Not Recommended: [31-32] Ill-fitting exterior aluminum storm windows viewed from both inside and outside are clearly not energy efficient.

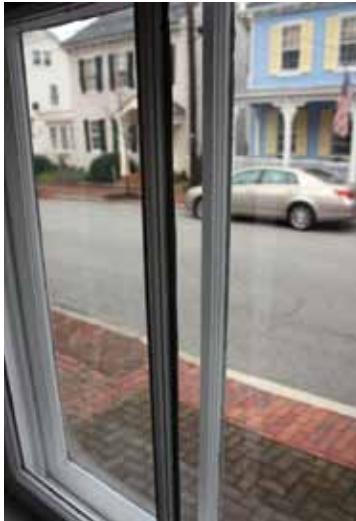
28

Recommended: [28-29] These exterior storm windows match the pane configuration of the historic interior windows in a residence and in a multi-story hotel building.

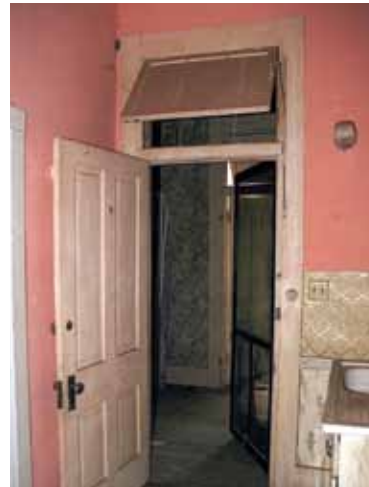
42
Recommended: [43] The wall and door glazing ensures that the corridor receives natural daylight and the operable transom helps air to circulate in this historic office building.

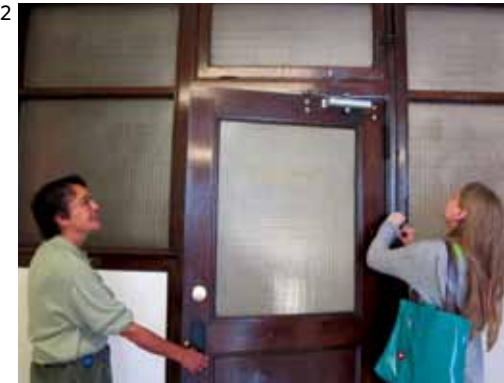
Recommended:
[44-45] A blower door test is a useful tool to help identify air infiltration in a historic building before undertaking weatherization or retrofit treatments.
Top Photo: Robert J. Cagnetta, Heritage Restoration, Inc.

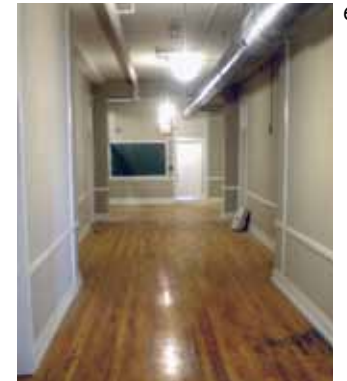
66

Not Recommended: [66] Interior ductwork has been inappropriately left exposed and unpainted here in this traditionally-finished school entrance hall.

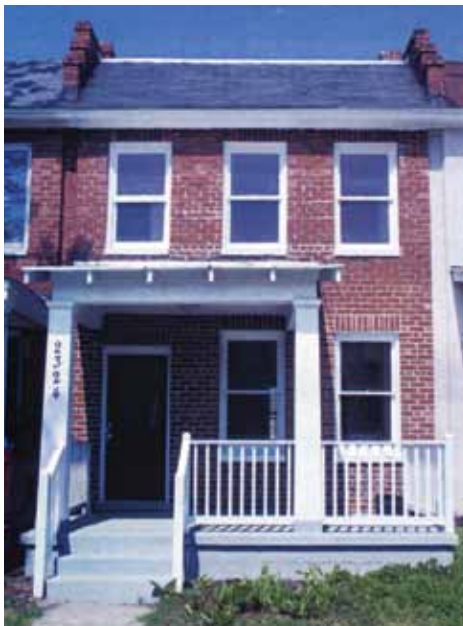
73

Recommended: [72-73] Solar panels were installed appropriately on the rear portion of the roof on this historic row house that are not visible from the primary elevation.

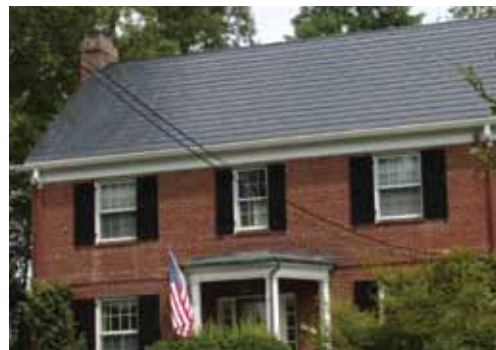
87

Not Recommended: [87] Historic roofing materials in good condition should be retained rather than replaced with another material perceived as more sustainable, such as, in this case, solar roofing shingles.

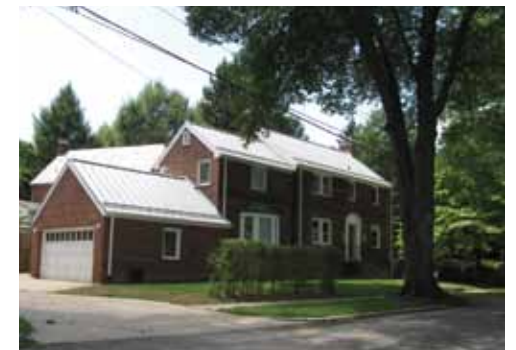
88

Not Recommended: [88] This new, cool white metal roof is not an appropriate material or color for this historic mid-20th century house.

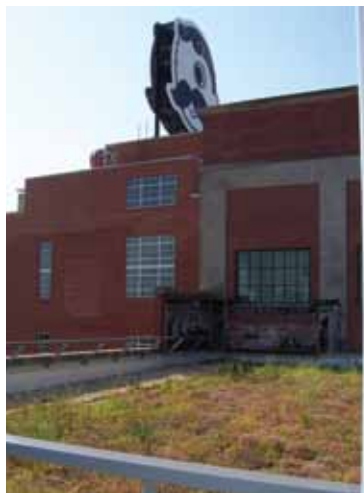
89

Recommended: [89-92] Low-scale and sustainable native plants are appropriate for these roof gardens on historic buildings.

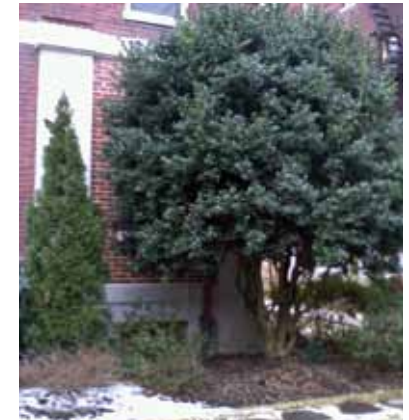
97

Not Recommended: [97] This tree, which was planted too close to the building, has caused the masonry wall to retain moisture that damaged the mortar and required that the brick be repointed in this area.
